Inspection Report

Property Address:
2525 West Algonquin
Edmonds WA 98020

Preferred Home Inspection Services Inc.

General Summary

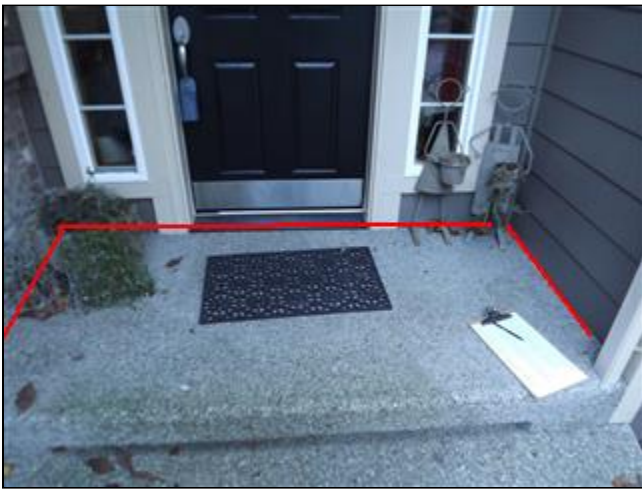
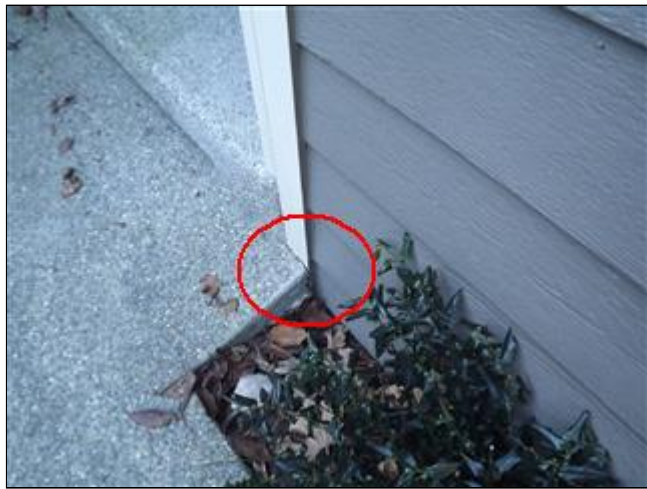
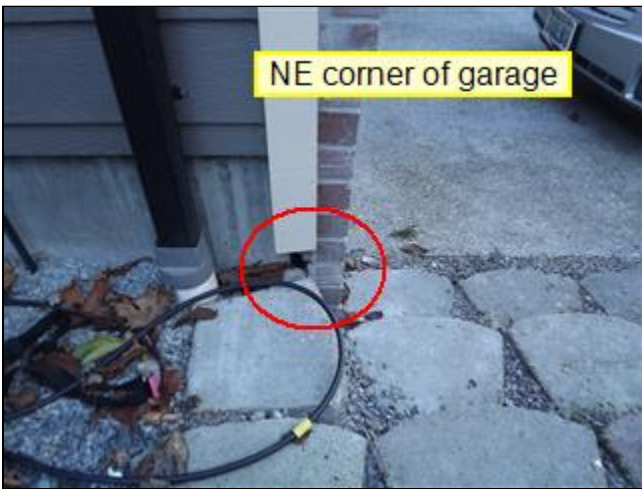
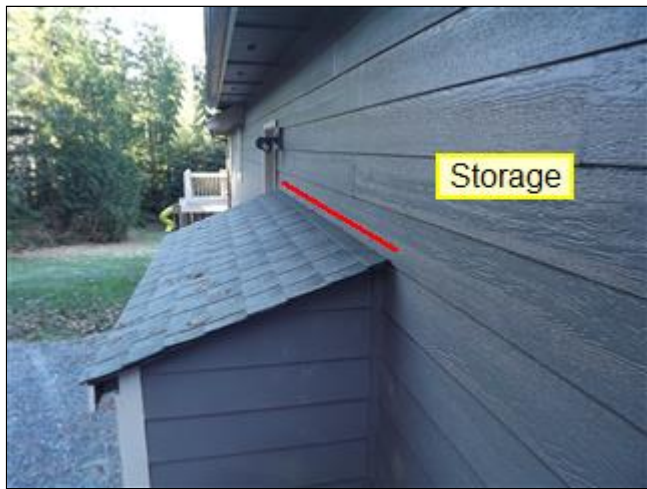
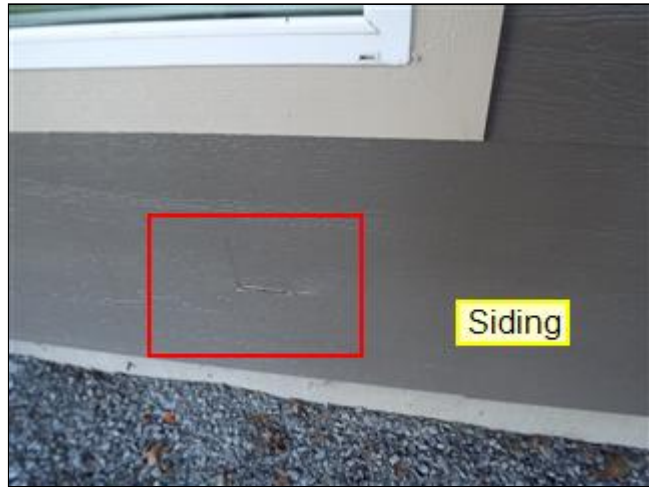
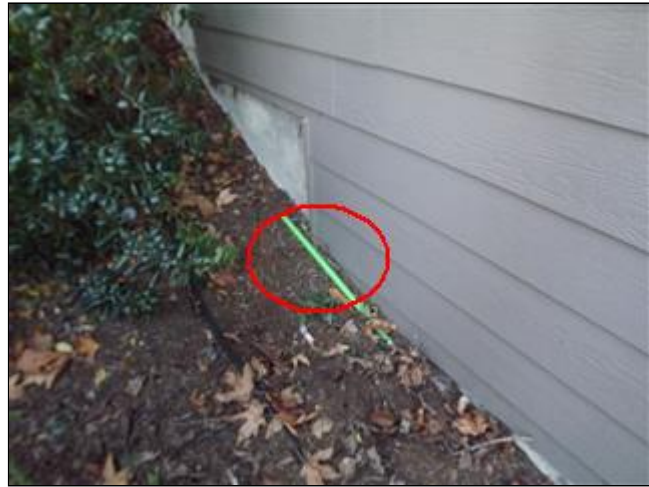
2.0 East entry stoop: Stoop is in good shape. Stoop appears to not have settled over the years. This is a good thing. Recommend maintaining a good seal around the perimeter of the stoop where it meets the siding to keep water from entering behind the concrete.

East entry: Recommend sealant where concrete meets the wood corner trim.

NE corner of garage: Recommend filling hole between siding and brick veneer. This is to keep insects from nesting behind brick.

South side of garage: Storage shed was not flashed to keep water from entering the shed. No recommendation.

West side: Minor hole in siding above GFCI outlet. Recommend sealant.

West side: Minor break in siding under SW bedroom window. Recommend repair.

North side: Wood to ground contact in a few areas where foundation steps down with the grade of the ground. This is conducive to moisture rot and insect damage. Recommend 4 to 6 inches between siding and dirt.

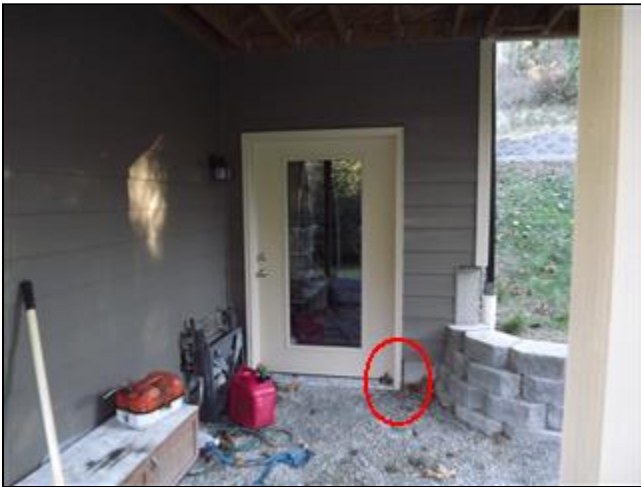
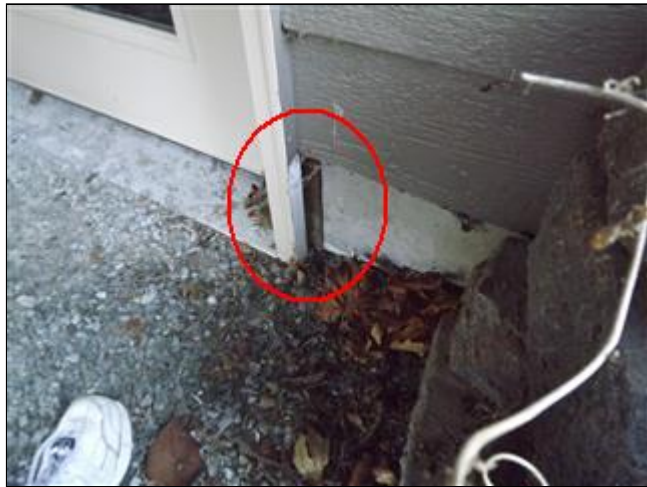
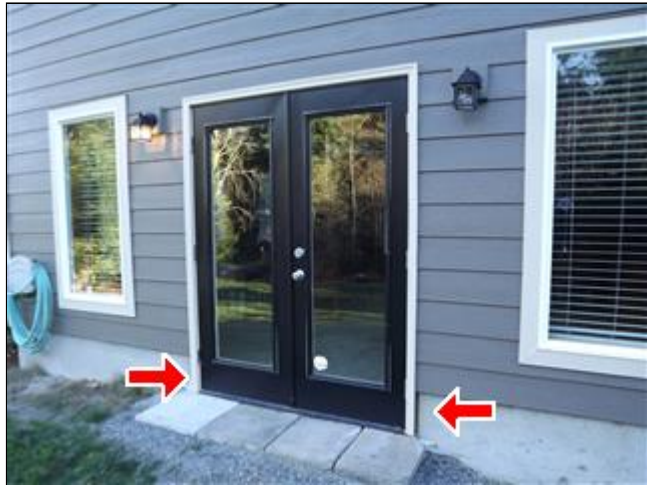
2.3 West side exterior doors: Recommend wood trim and paint at the lower corners of the door jams to protect wood framing members.

Safety Hazard: Garage to house service door is a fire rated door. Having a pet door in this door compromises the fire rating. Recommend new door.

Door to deck from house: Weather stripping damaged. Recommend repair.

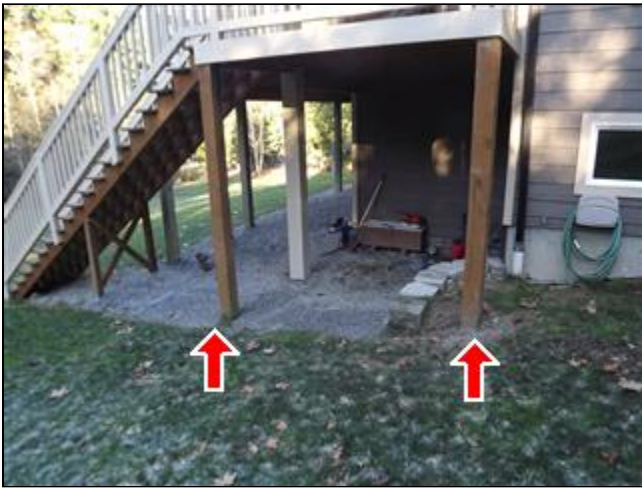
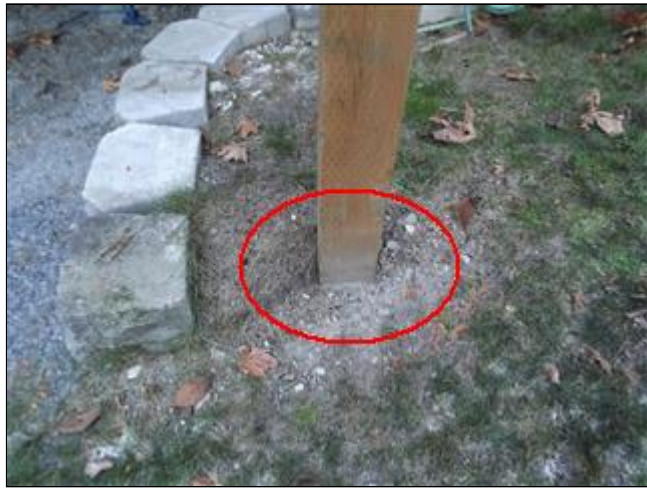
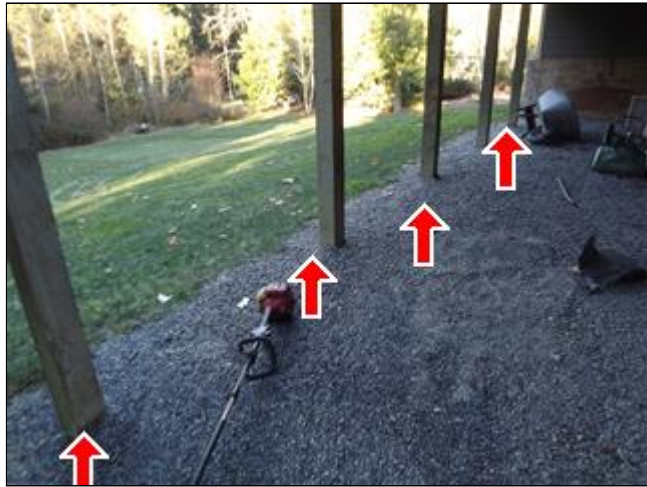
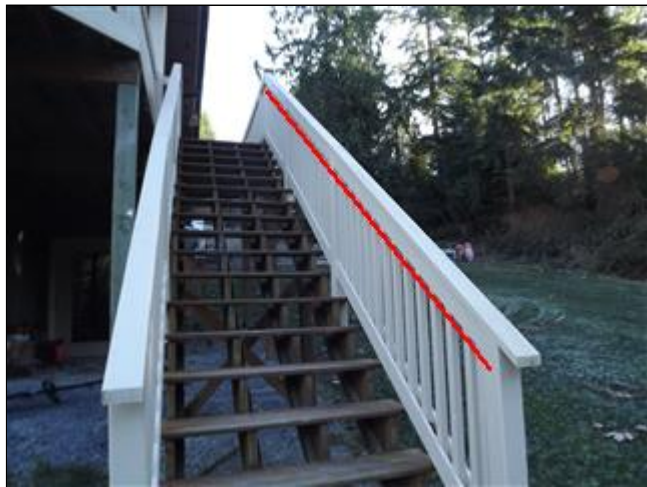
2.5 Main deck on the west side of house: Wood to ground contact with treated 6 X 6 posts. Wood to ground contact is conducive to moisture rot and insect damage. Post have no evidence that there is deterioration at the time of the inspection. Recommend keeping dirt line below bottom of posts.

Deck: Deck ledger board has been lagged to house approximately every six feet. Required every four feet. Recommend additional 3/8 inch to 1/2 inch lags through ledger board to house.

Deck stairs: Stairs required to have a graspable handrail Recommend handrail to one side of railing.

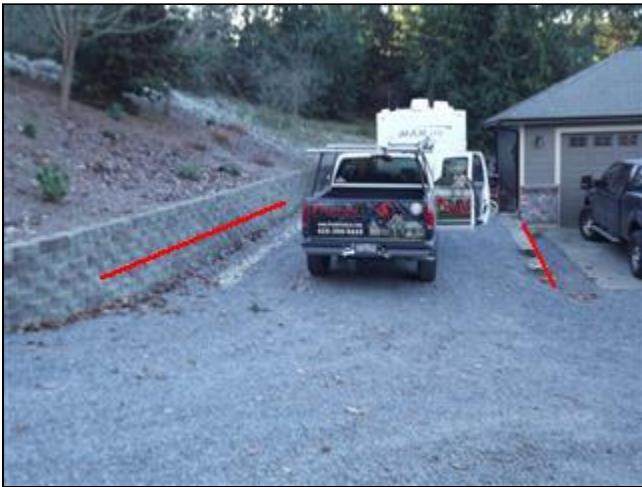
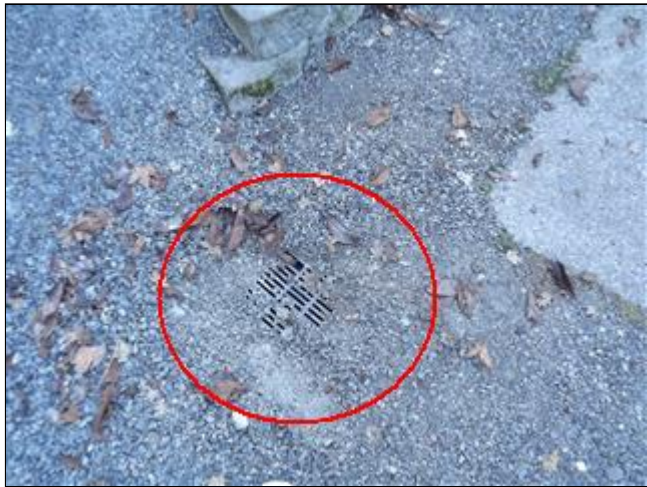
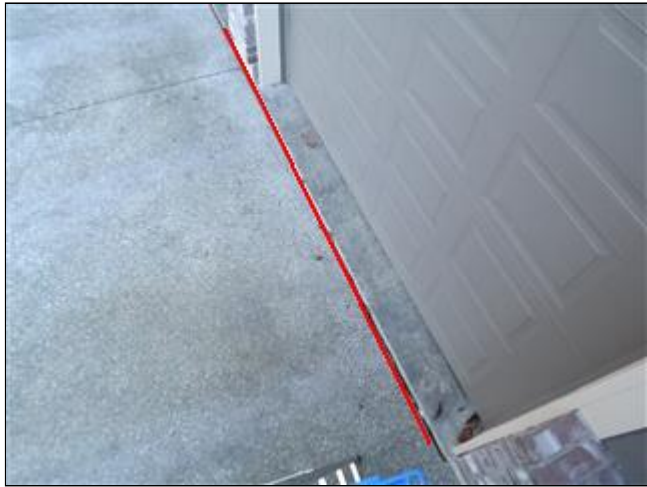
2.6 All retaining wall appear to be built correctly as to how they might affect the house. Found no bulges or failing areas of the retaining walls.

Driveway: Driveway has cracks in the controlled joints. Concrete will crack. This is where you want them to crack. Found start of surface cracking in NW corner of driveway. Same area has dropped approximately one inch from adjacent concrete. This settling may continue causing a trip hazard for people. Recommend sealant to all controlled cracks to keep water from migrating under the slab which can over time undermine the concrete slab.

Driveway drain at the end east corner of the driveway has a cracked cover and is filled with gravel. Recommend keeping gravel and debris out of the catch basin so that the drain works properly.

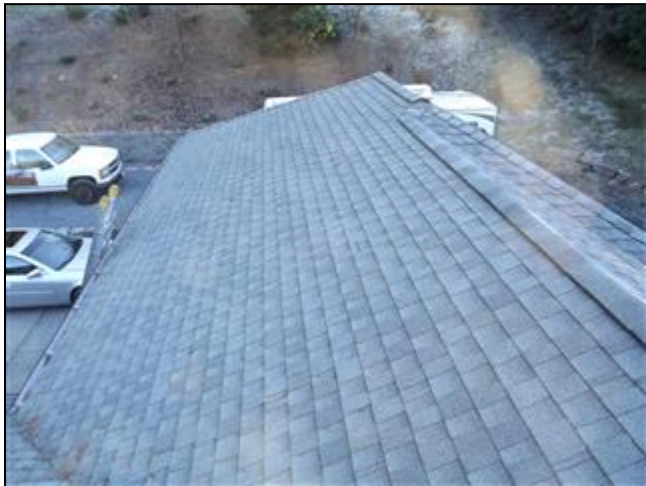
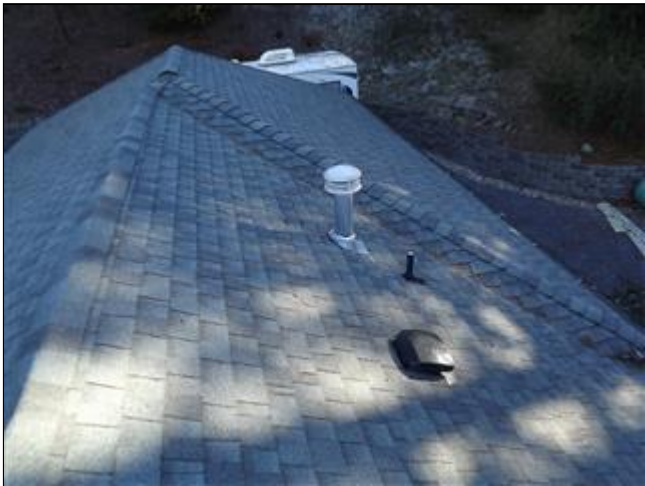
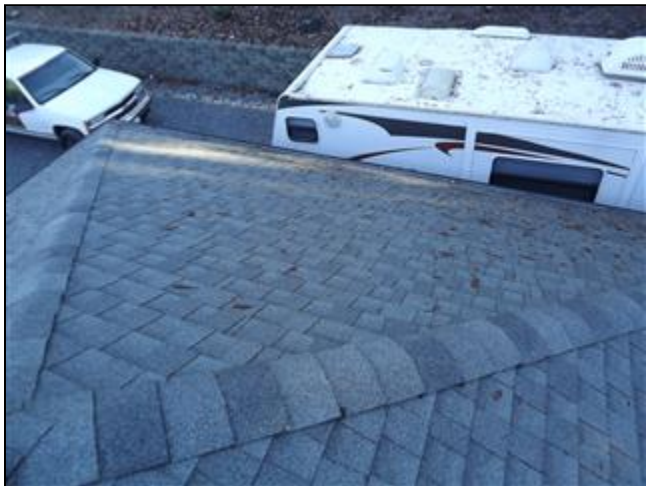
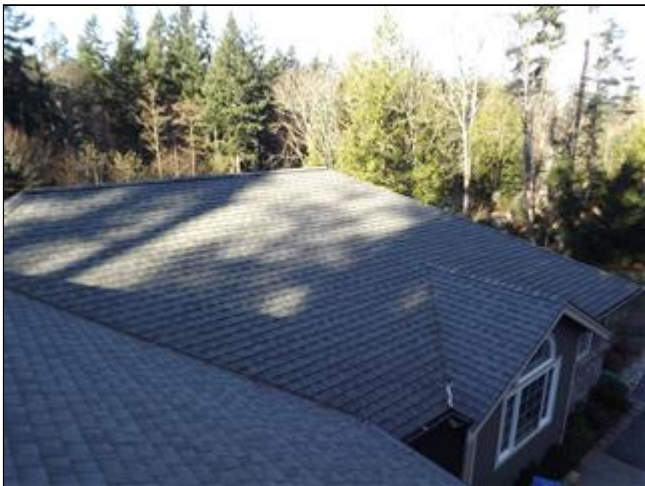
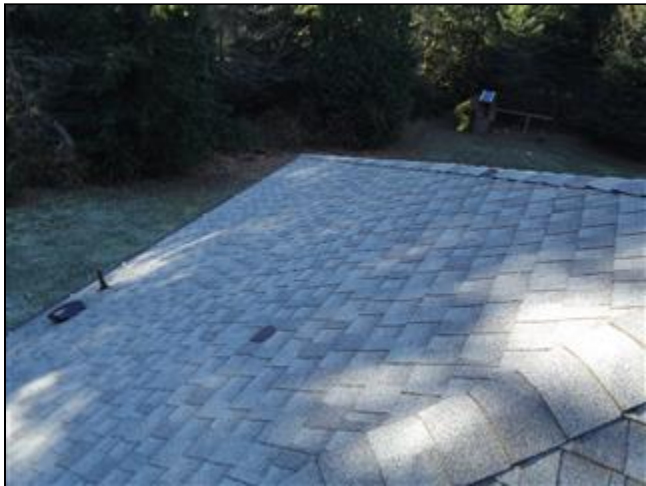
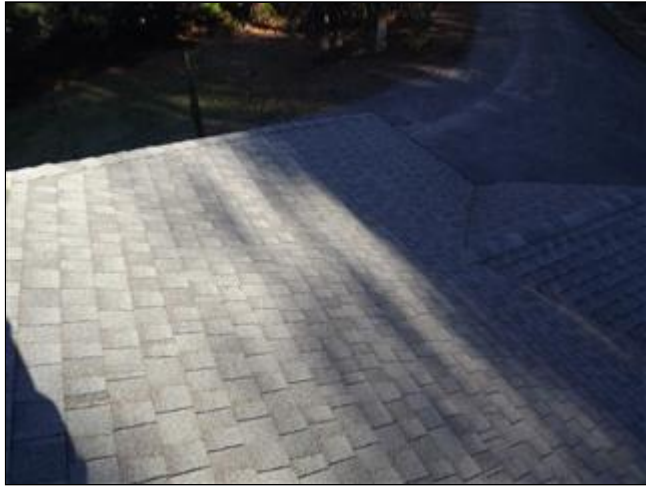
3.0 This home has a architectural 30 year roof composition. Roof is in good shape. Some evidence of moss starting to build up. Recommend routine maintenance to keep the moss growth to a minimum.

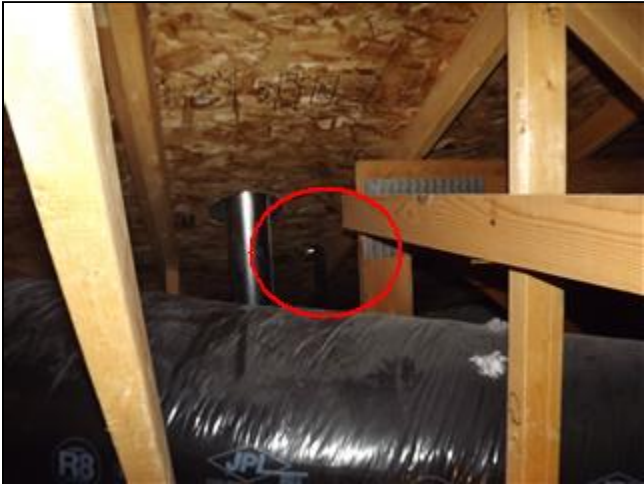
3.2 Picture 1

3.2 Minor: South side of roof: Found one plumbing vent that needs to be better secured to roof line to keep insects from entering the attic just adjacent to the furnace gas vent stack.

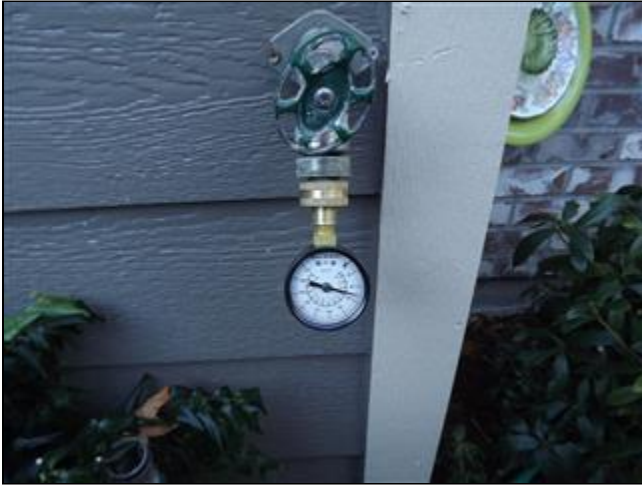
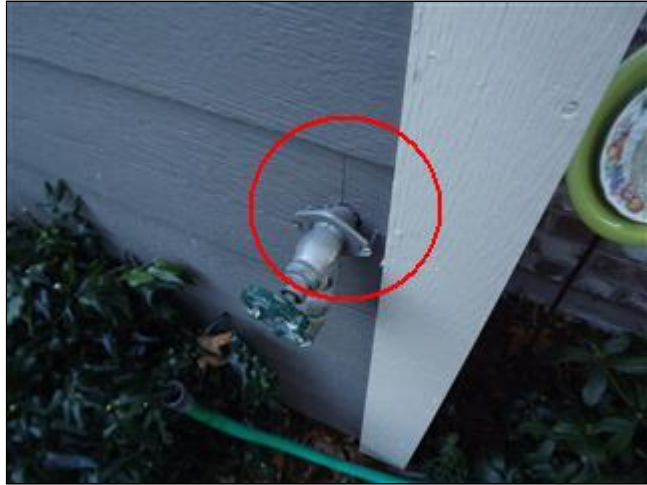
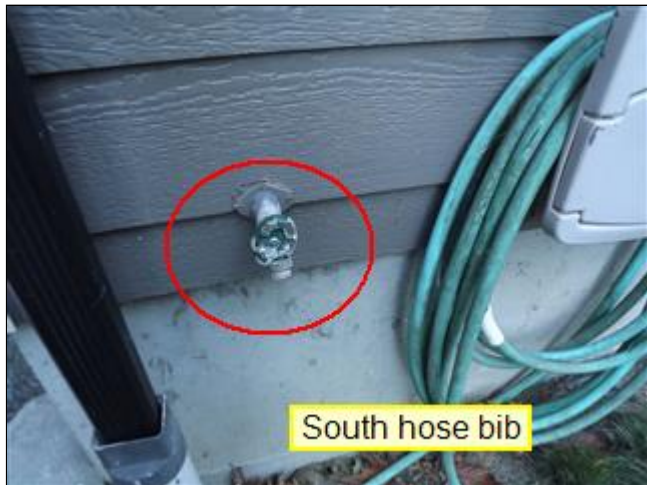
Recommend sealant around hose bibs to keep moisture out from behind the siding.

NW hose bib: Could not operate valve. May be frozen shut. Recommend repair.

Recommend hose bib covers during cold months.

South hose bib: No water to hose bib. May be shut off on purpose. Recommend repair if needed.

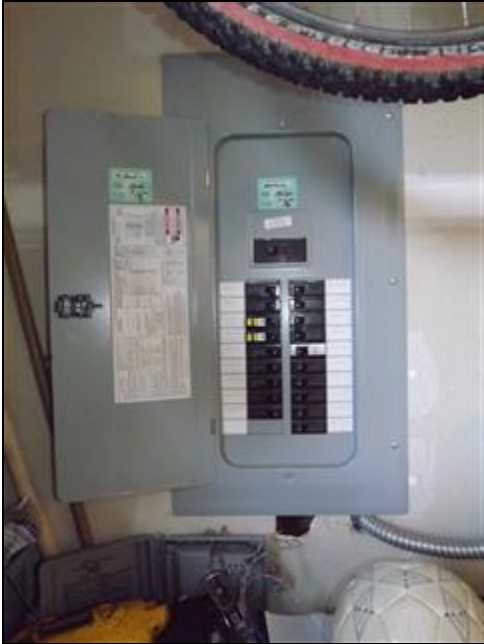
5.1 Picture 1

Inspected inside of panel. All connections are correct.

Service panel box: Knock out blanks missing at bottom of box. In case of fire in the service panel box, it is designed to contain a fire within the box. Missing knock out plates compromises this intent. Recommend sealing open holes in panel box.

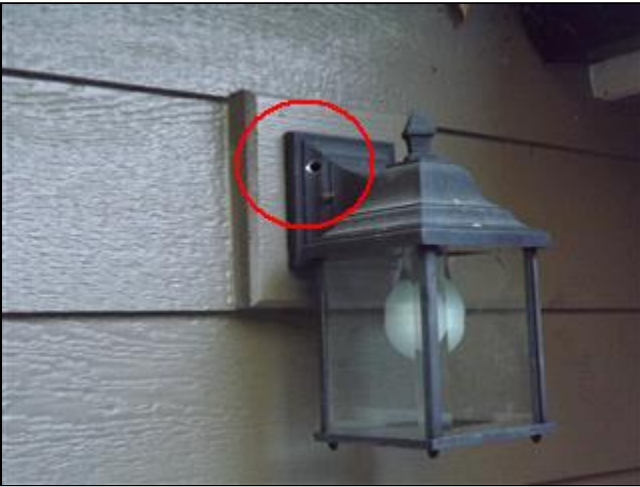
5.4 Picture 1

5.4 East side: Minor hole in light trim. Recommend filling with sealant to keep insects and moisture from entering here.

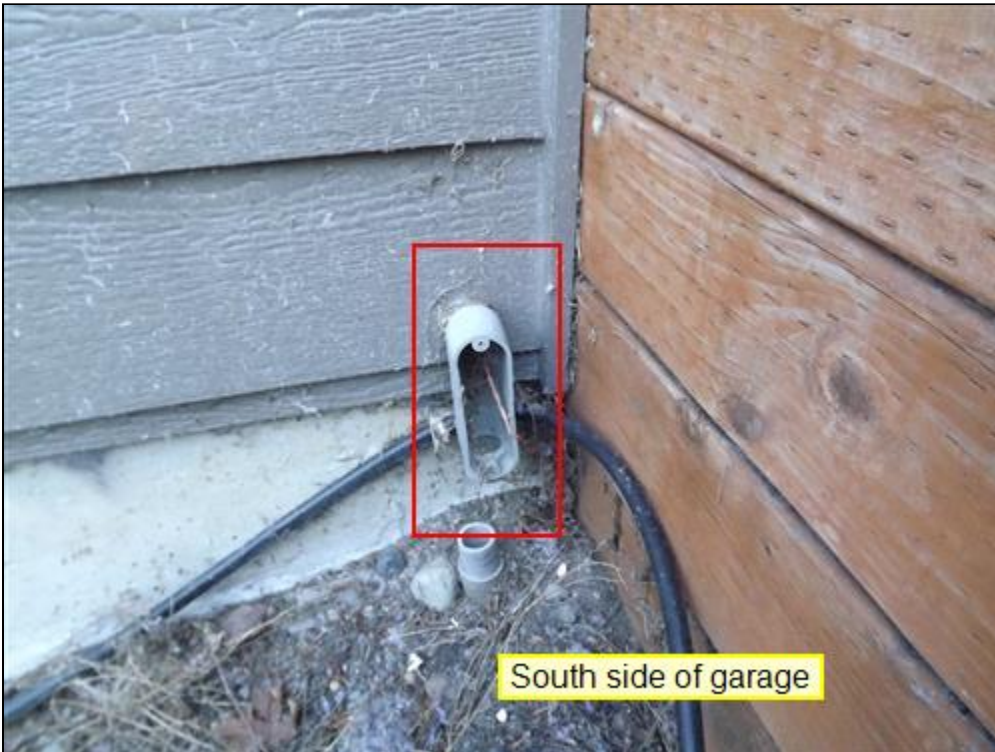
5.4 Picture 2

South side of garage: Recommend asking owner what this low voltage wiring services. Recommend cover plate to conduit box.

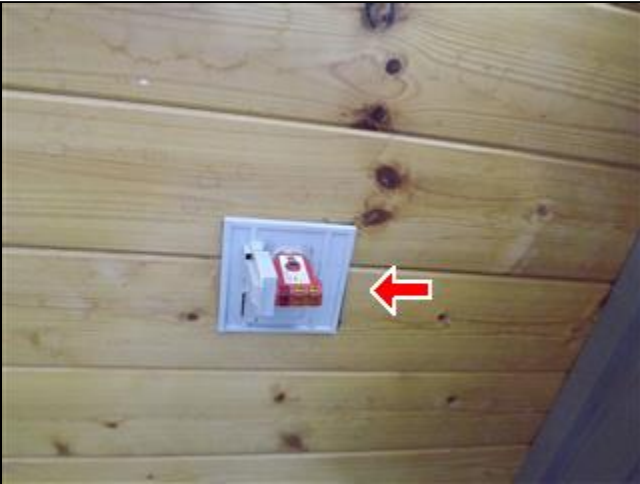
5.6 Picture 1

5.6 East side exterior: Soffit GFCI did not work. Did not notice if they were out at the electrical panel. Recommend asking owner if they indeed work. Recommend repair if not working.

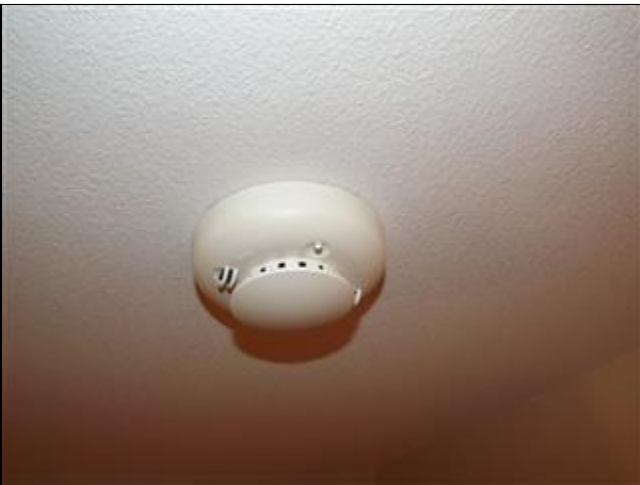
5.8 Picture 1

5.8 This home is equipped with smoke detectors that I am not familiar with. Smoke detectors show that there is a way to test them but I could not get one to activate. All smoke detectors are hard wired to the house. Recommend asking current owner how they work. Recommend testing all smoke detectors prior to moving in and make repairs as needed.

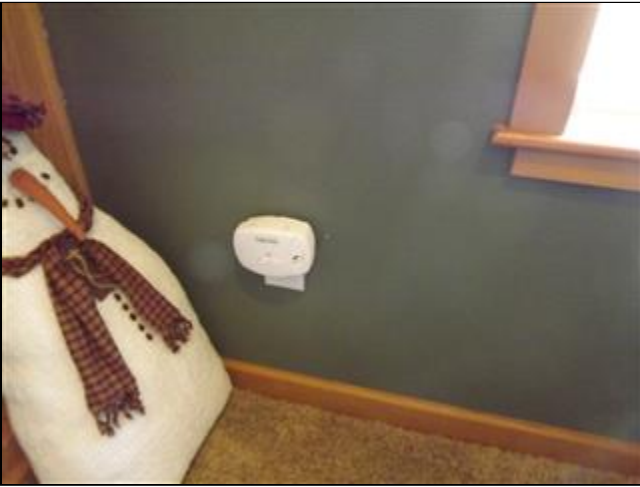
5.9 Picture 1

5.9 Carbon monoxide detector present on the upstairs main floor.

CO detectors required on each level. Recommend additional CO detector downstairs.

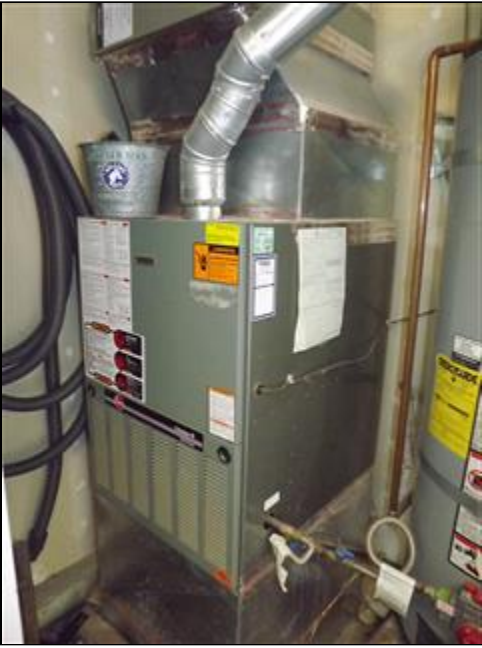
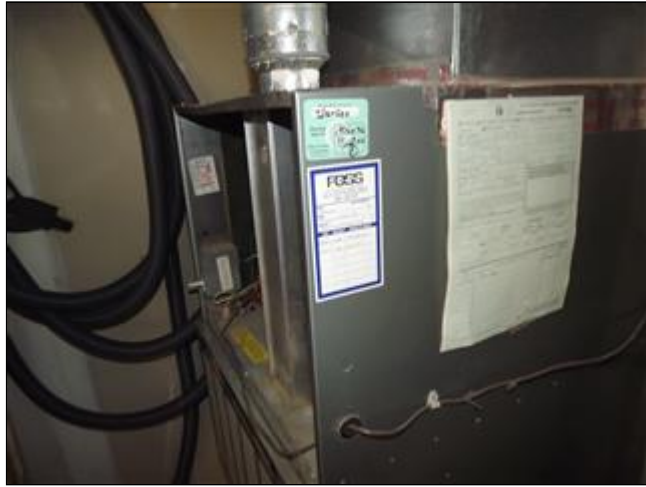
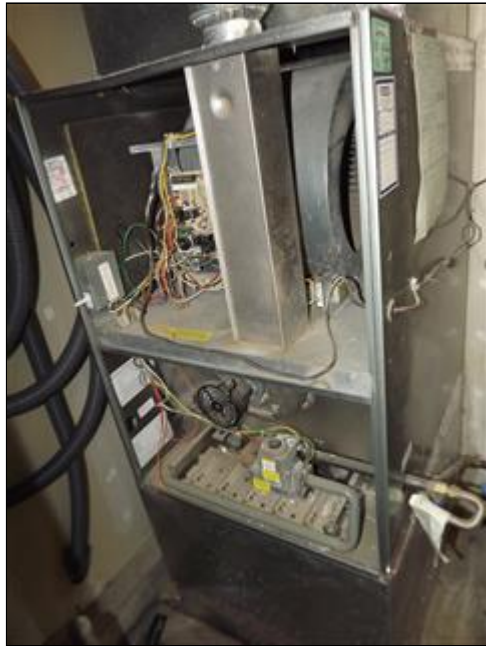
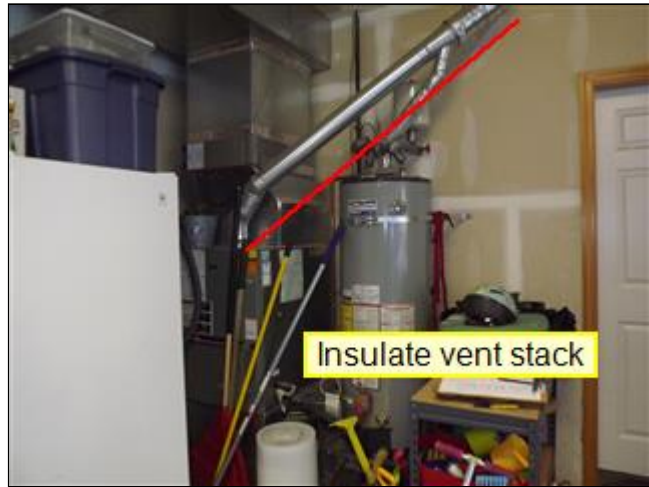
No current service tag on furnace. It is recommended that furnace be serviced every two years for optimum efficiency. Recommend servicing furnace by licensed HVAC professional.

Note: White powder substance is caused from condensation in the gas vent. This occurs because the gases in the vent are warmer than the air outside the vent. To minimize this it is recommended that the vent pipe be insulated to the garage ceiling.

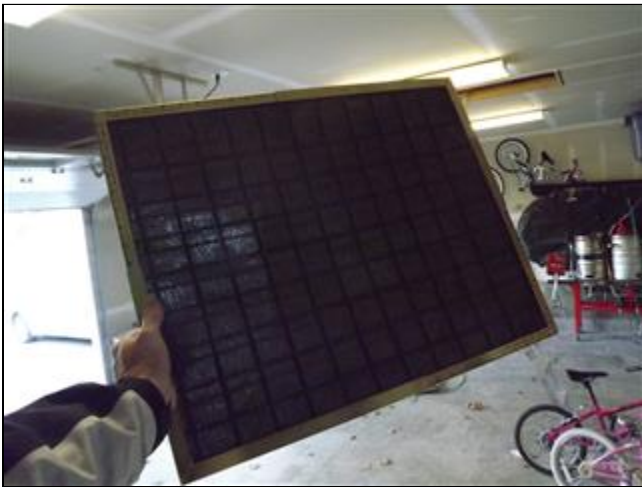
6.5 Picture 1

6.5 Filter appears dirty. Recommend cleaning.

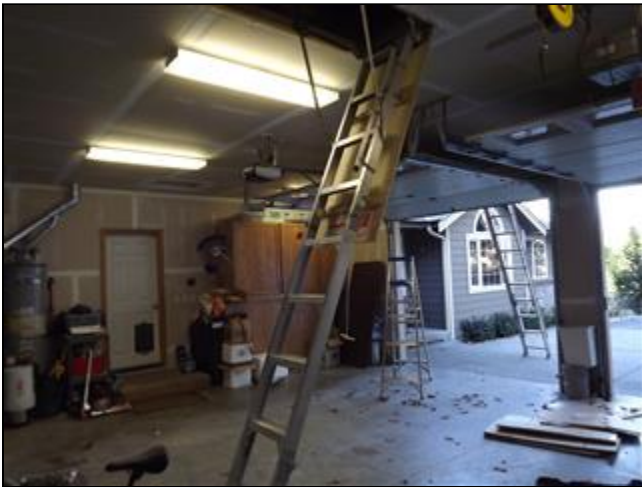
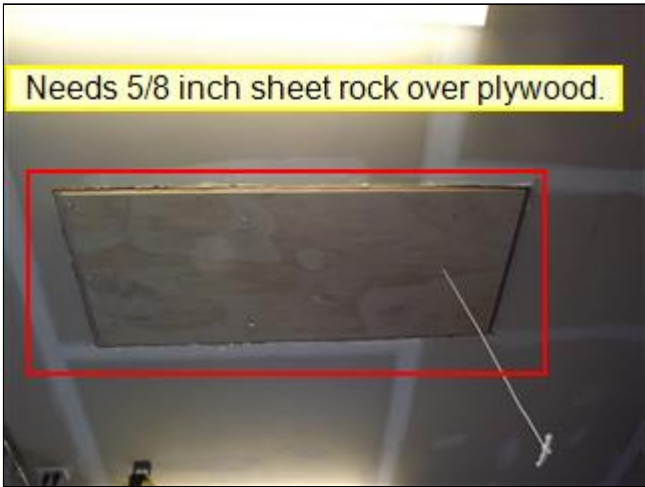
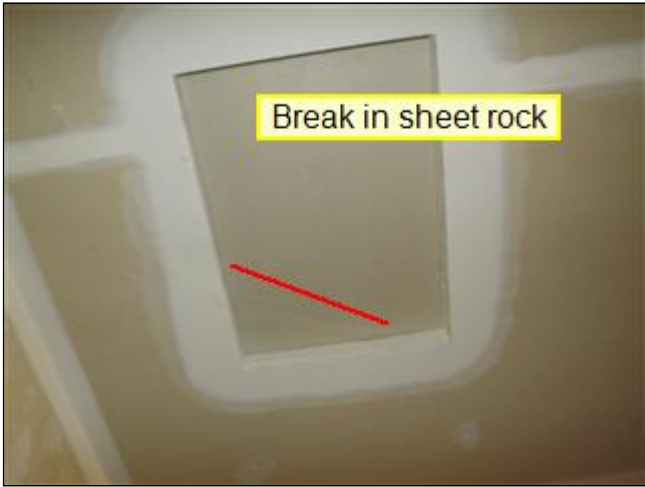
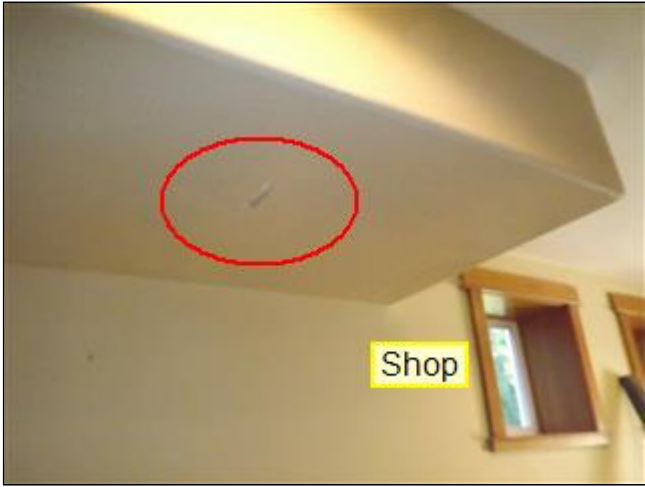
7.1 Safety Hazard: Garage: Pull down stairs are great for accessing the attic for storage. Garage ceiling has 5/8 inch sheet rock to maintain the proper fire rating from the garage to the house. The pull down stairs compromise this fire rating. Recommend installing 5/8 inch sheet rock over plywood of pull down stairs.

Original attic access cover: Broken sheet rock. Recommend repair.

Living room: Minor taping to ridge joint needed. Screw hole pops are evident.

Shop area: Minor ceiling repair needed.

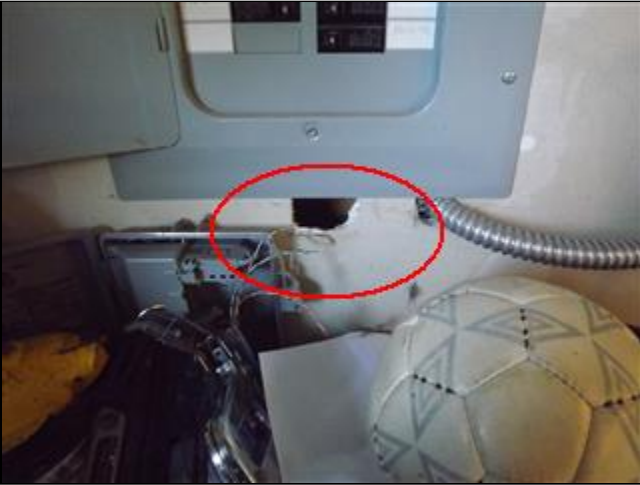
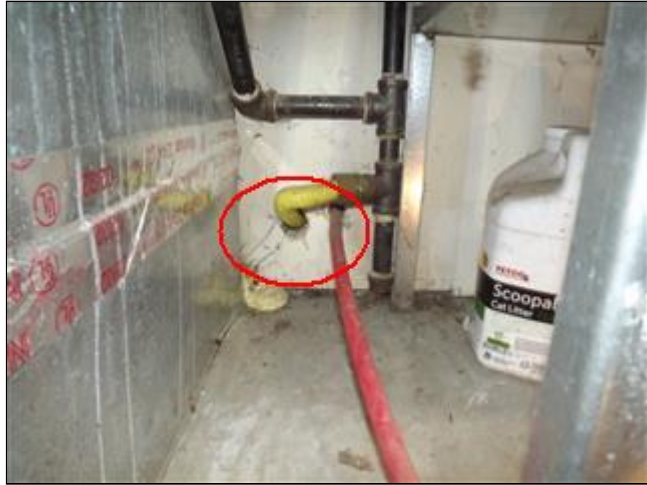
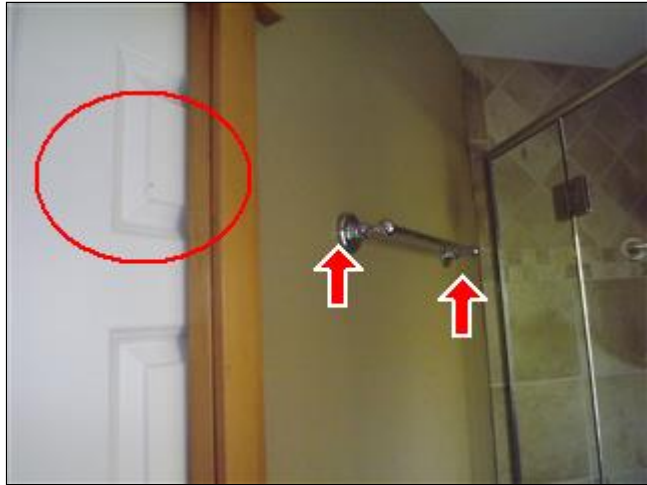
7.2 Garage: Small hole in sheet rock under electrical service panel. Recommend repair.

Garage: Recommend sealing gaps around gas piping behind furnace to keep small rodents from entering the wall at this point.

Living room to hall: Minor wall repair needed.

Note: Master bathroom: Towel bar screws are just long enough to start scratching the pocket door.

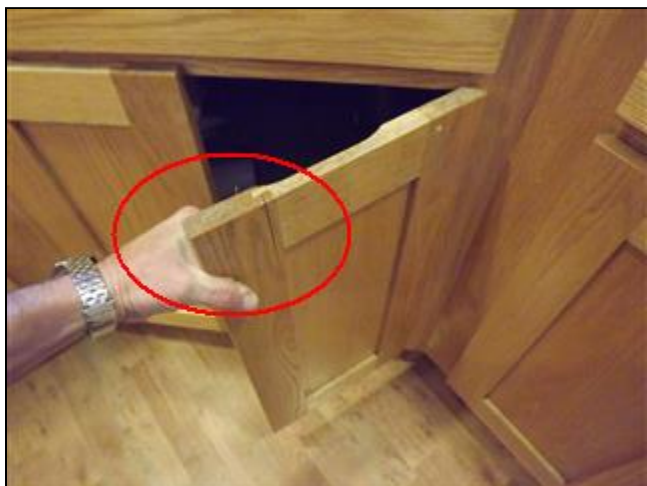
7.5 Picture 1

7.5 Kitchen: Cabinet door below sink has framework that is coming apart. Recommend minor repair. This is normal wear for a house of this age.

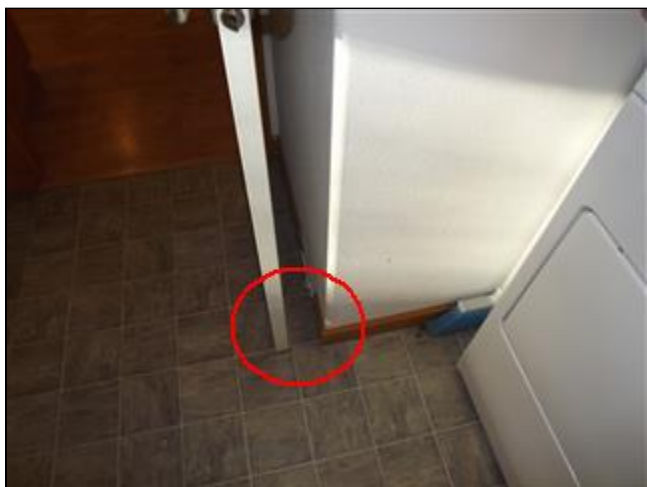
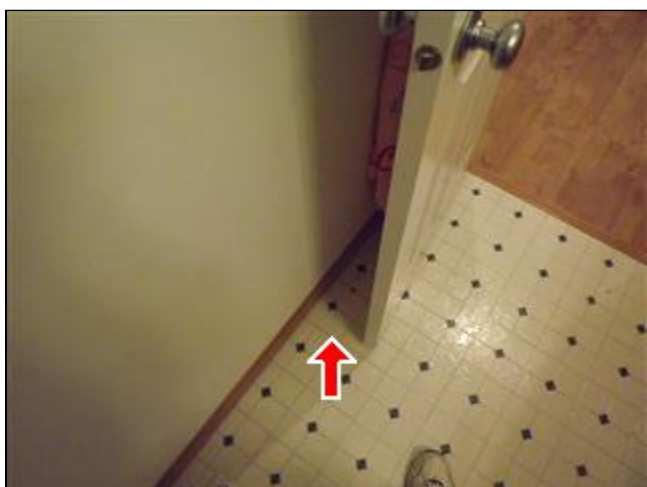
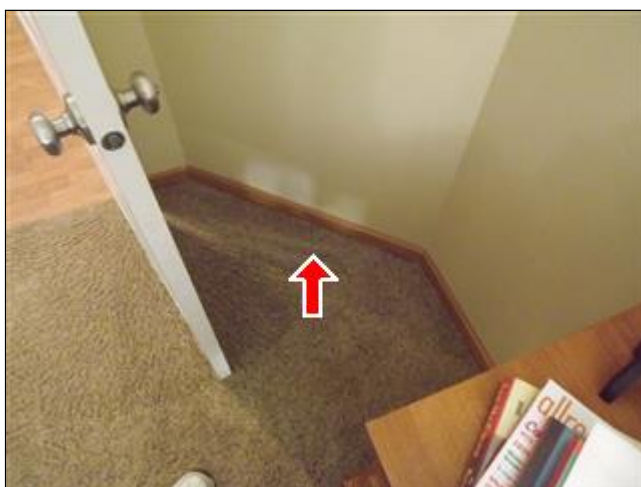
7.6 Upstairs doors need door stops throughout.

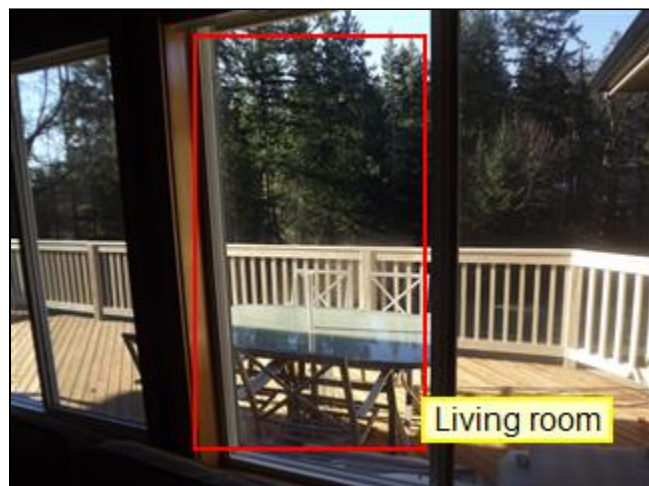
7.7 Picture 1

7.7 Living room: Tinting application on west windows installed to shade west windows. Found one living room window where this film appears to be coming off giving the window a foggy look. Recommend minor repair.

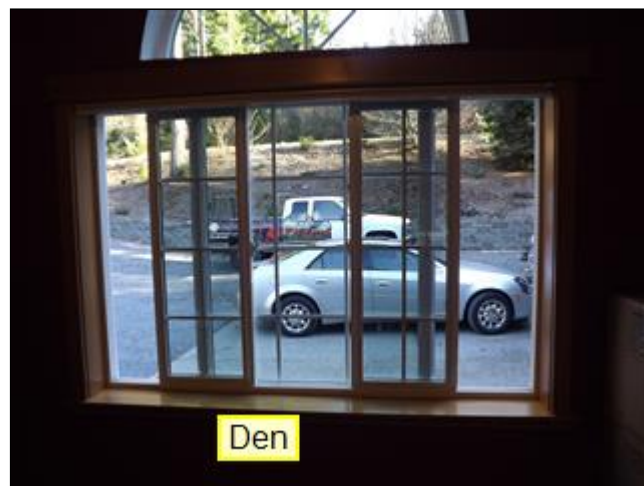
7.7 Picture 2

Den windows: Missing screens. Recommend screens.

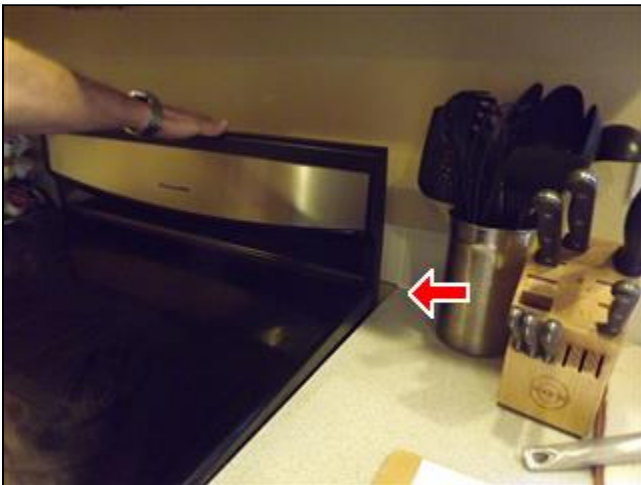
9.1 Picture 1

9.1 Safety hazard: Ranges have no tip out protection. Recommend installing tip prevention brackets.

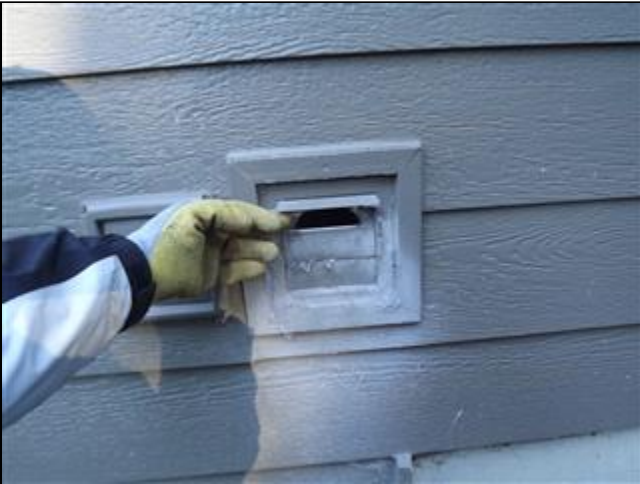
9.7 Picture 1

Note: Recommend cleaning dryer vent.
