Inspection Report

Property Address:
2525 West Algonquin
Edmonds WA 98020

Preferred Home Inspection Services Inc.

General Summary

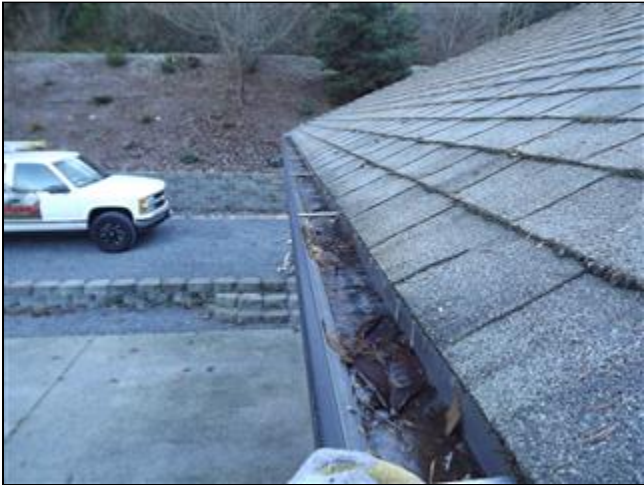
3.3 Picture 1

3.3 Gutters are clean.

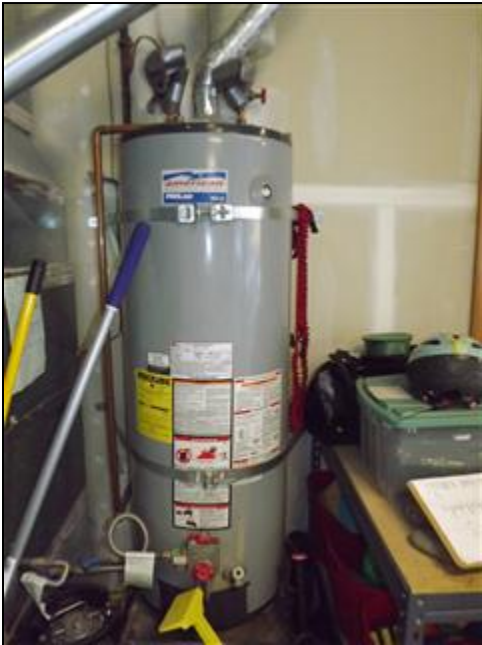
4.3 Picture 1

Water heater has the proper earthquake strapping installed high and low on tank and properly connected to the wall.

Water heater has the proper gas venting and water connections.

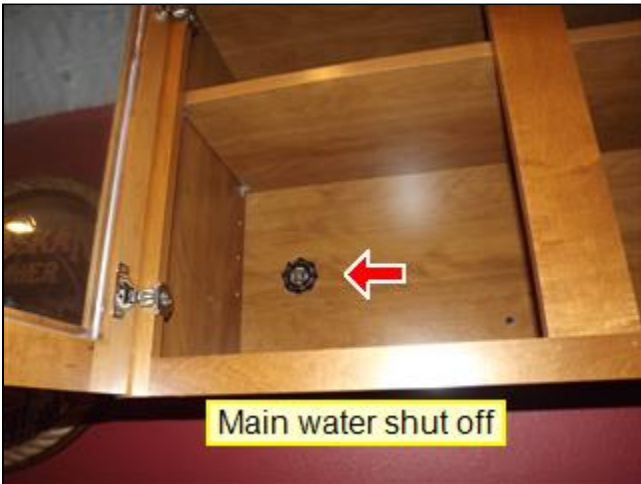
4.4 Picture 1

4.4 Located in the basement in a cabinet next to the pool table. Recommend confirming this with the owner.

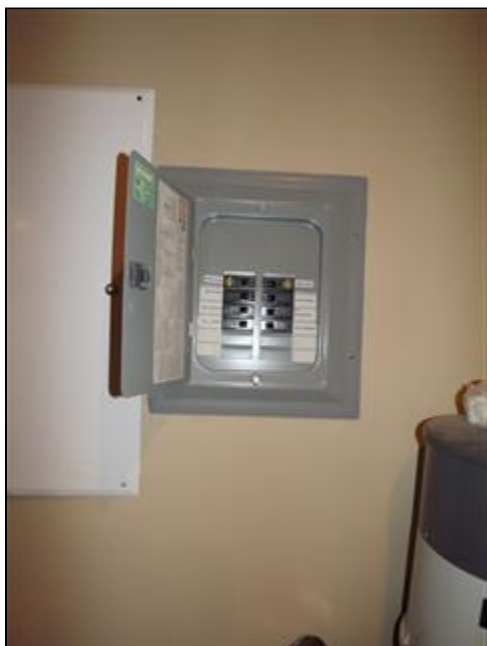
5.2 Picture 1

5.2 Proper grounding rod confirmed.

Inspected inside of panel. All connections are correct. No hazards found.

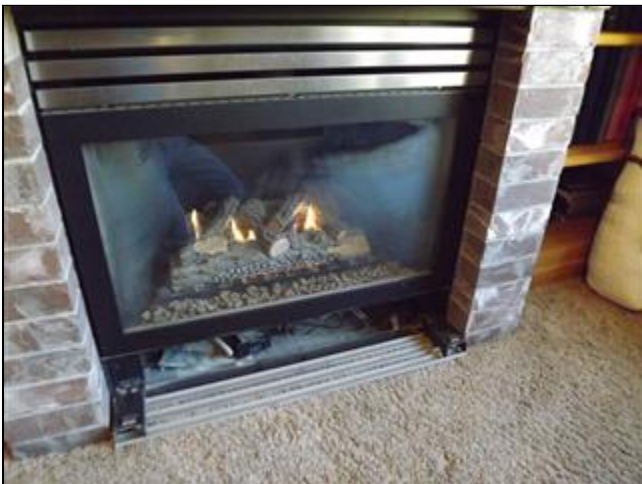
6.6 Picture 1

6.6 Both upstairs and downstairs propane operated correctly.

Note: Propane was off to the upstairs fireplace at the time of the inspection. I turned it on and lit the fireplace. I returned the gas supply to the off position after testing.

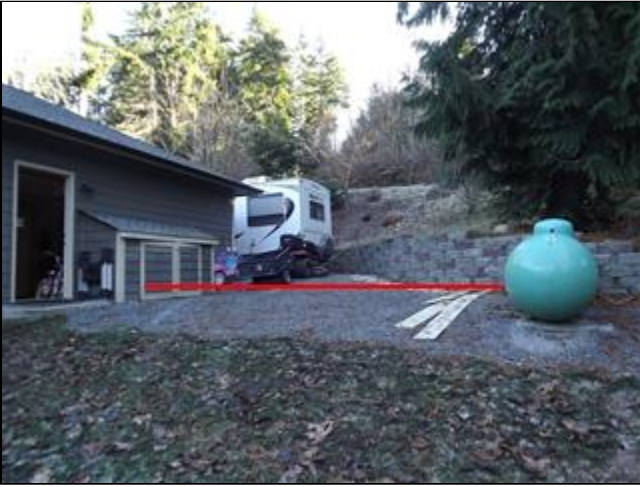
6.8 Picture 1

6.8 Propane storage tank is the proper distance from the house.

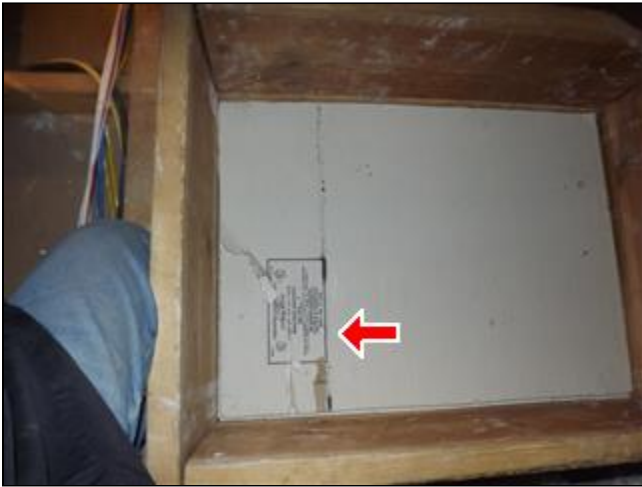
7.1 Picture 3

7.1 Safety Hazard: Garage: Pull down stairs are great for accessing the attic for storage. Garage ceiling has 5/8 inch sheet rock to maintain the proper fire rating from the garage to the house. The pull down stairs compromise this fire rating. Recommend installing 5/8 inch sheet rock over plywood of pull down stairs.

Original attic access cover: Broken sheet rock. Recommend repair.

Shop area: Minor ceiling repair needed.

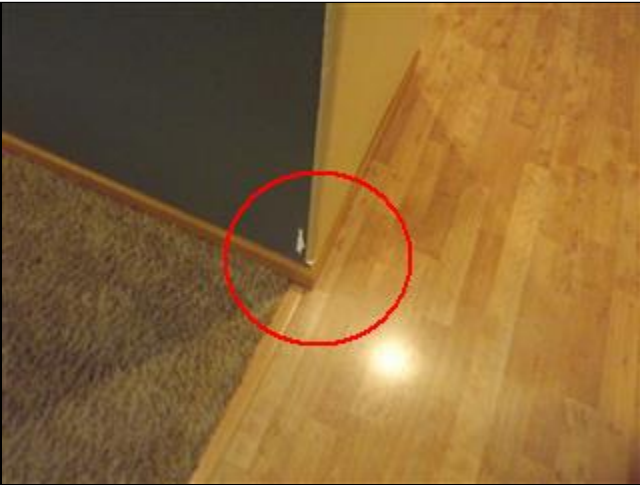
7.2 Picture 3

7.2 Garage: Small hole in sheet rock under electrical service panel. Recommend repair.

Garage: Recommend sealing gaps around gas piping behind furnace to keep small rodents from entering the wall at this point.

Living room to hall: Minor wall repair needed.

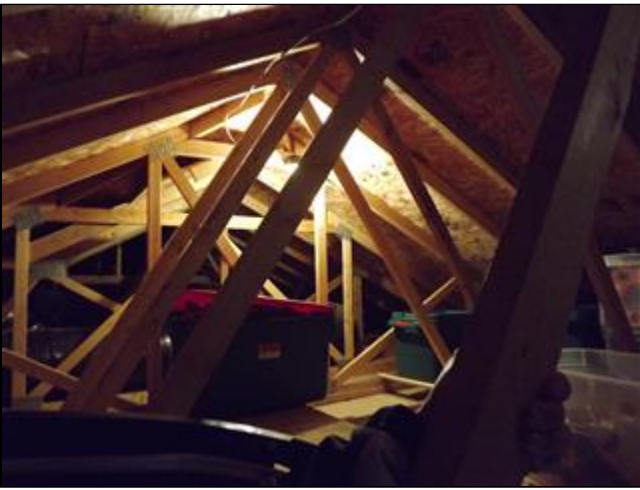
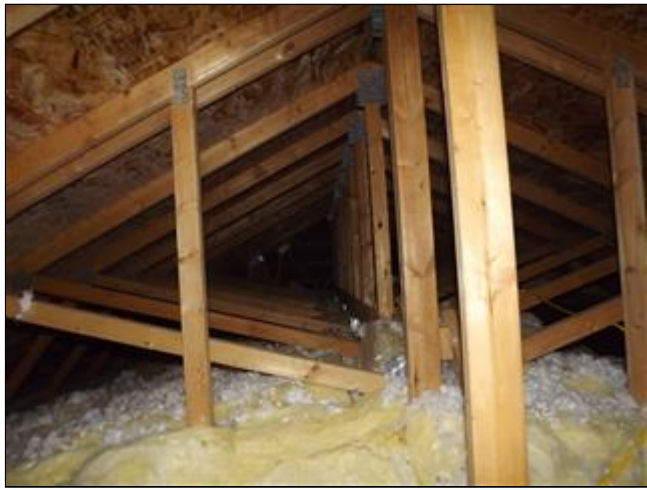
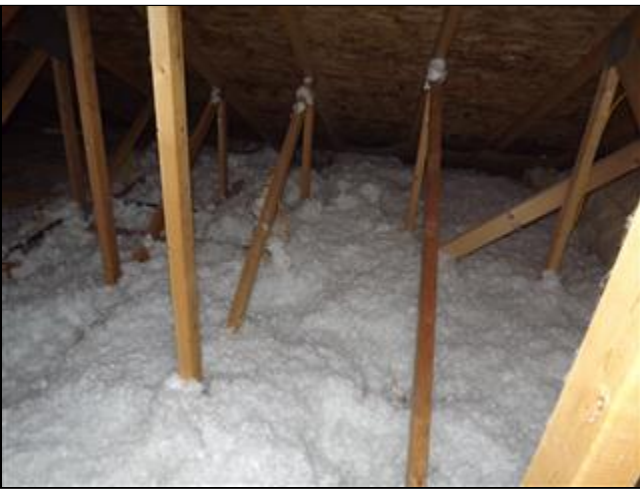
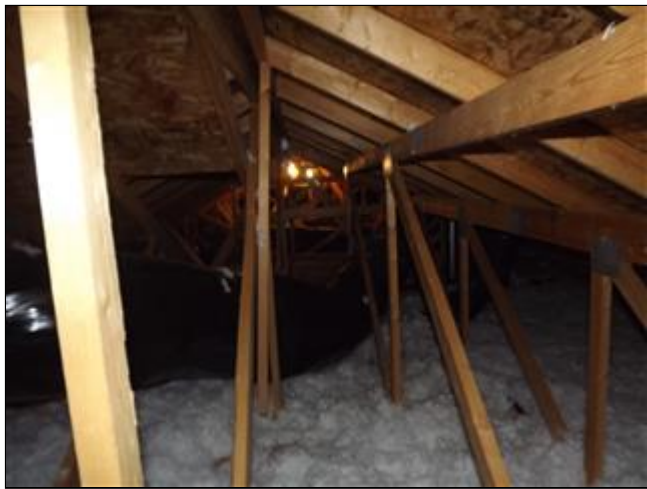
8.0 Attic: Insulation is in place. No recommendations.
